A Geologic and Geomorphologic Analysis of the Zacatecas and Guadalupe Quadrangles in Order to Define Hazardous Zones Associated with the Erosion Processes

Felipe de Jesús Escalona-Alcázar, Bianne Escobedo-Arellano, Brenda Castillo-Félix, Perla García-Sandoval, Luz Leticia Gurrola-Menchaca, Carlos Carrillo-Castillo, Ernesto-Patricio Núñez-Peña, Jorge Bluhm-Gutiérrez and Alicia Esparza-Martínez

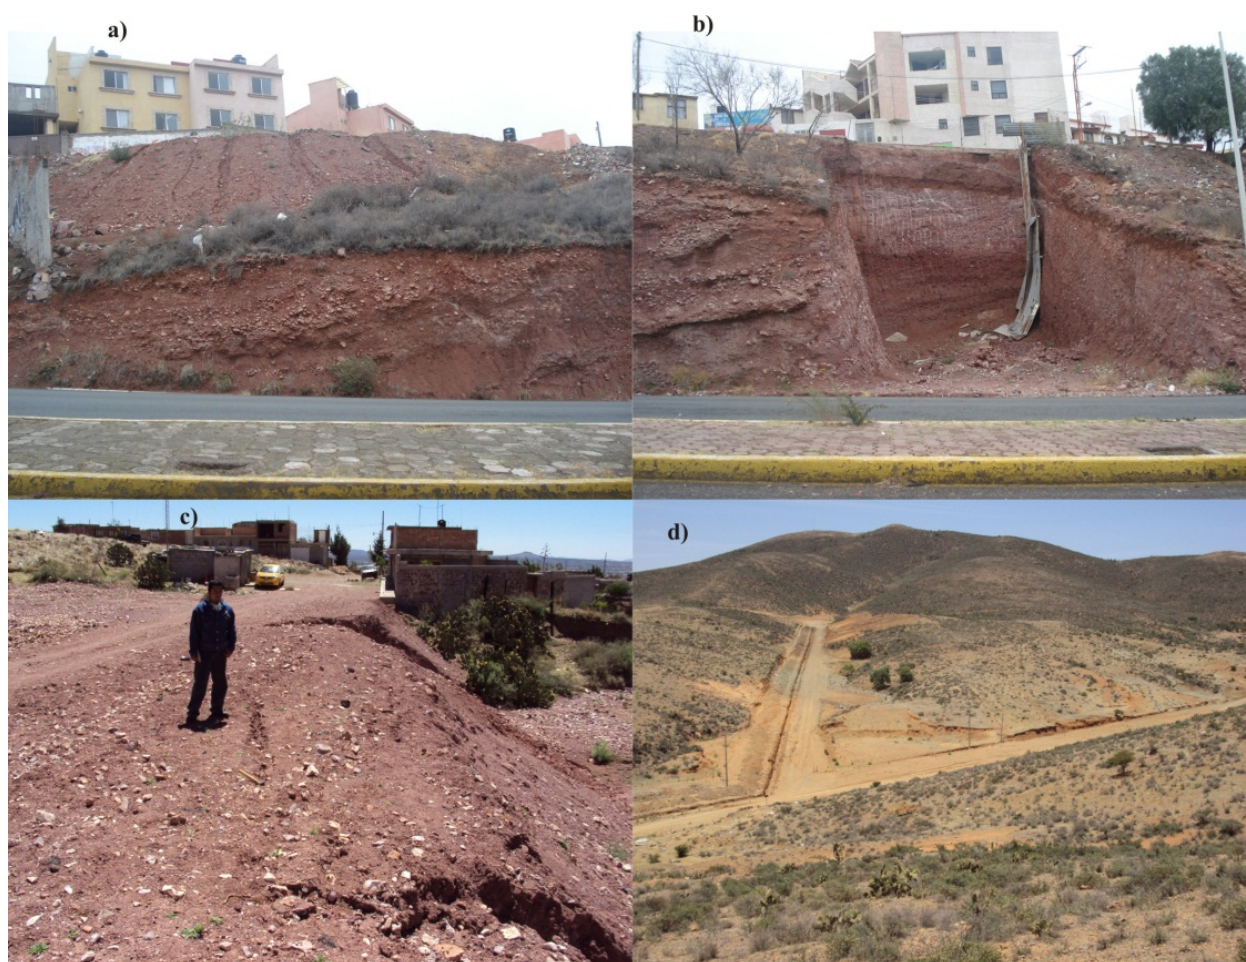
Figure 13. Field verification of the proposed model for hazardous zones associated with erosion. a) Moderate erosion zone; in the filling deposit can be seen gullies formed after the rainy season; whereas the conglomerate is affected by differential erosion. b) Intense erosion zone. An excavation was made

for unknown reasons. The effects after the rainy season were that the wall and sidewalk fall. c) A Low erosion zone in a semi plain area; more than one year after the road was built, large gullies developed. d) An intense to moderate erosion zone. The undisturbed area is in the intense erosion where no visible effects are seen; while the moderate one is where the streets are traced.

The results shown in **Figure 12** were verified in the field and they are presented in **Figure 13**. The erosion removes unconsolidated materials if the original conditions are changed; otherwise the process is very slow. The velocity at which erosion acts depends on the zone they are in. The model here defined should be taken into account for the urban development planning. This model locates areas potentially affected by erosion if the landscape is modified.
